Detail of lock gates

*Images modified by John R. Groves 09-12-05, Chili, New York*

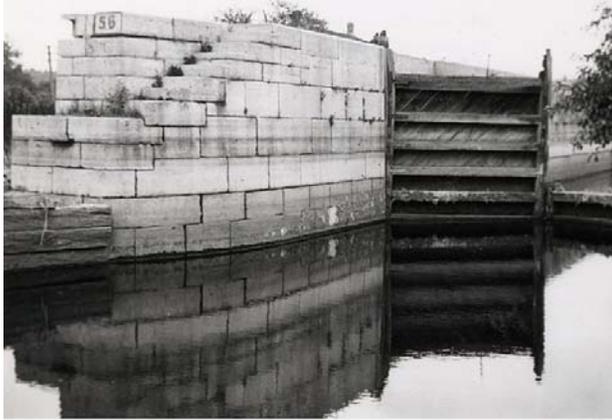
Chimney missing

Top of quion post

E-56 Sign

The two chimneys are probably original to the “grocery”. Later, and possibly during a fire in the attic, I believe around the 1960’s the west chimney was removed. The fire nearly destroyed the structure. Had not the Perry family been in residence we would surely have lost that building. If that were the case there probably would only remain a field stone foundation and some memories.

The “odd structure” turns out to be the top of the quoin post. The quoin post supported the gate in a recess in the lock “gate recess”. This post of wood formed a hinge by which the gate was opened and closed. What is seen here is the square notch that fitted into the “balance beam”. The balance beam is a large wood structure that serves two functions:

There is an earlier image of this lock taken around the turn of the century (i.e.1900). This image to be analyzed and presented on the E-56.org site soon, shows the E-56 sign missing, as seen in this image. This could be the result of the early image being a copy, where details are simply lost in shadow or resolution. In the early image there seems to be something there, but it isn’t clear if it is the E-56 sign seen above. When looking at old photographs it is fascinating to record things that are seen and not seen in other images of the same subject. This can be useful when trying to date images. One means of determining lost resolution is through enlargement, printing and viewing at a distance. This method will be applied to the E-56 sign. Results TBA!

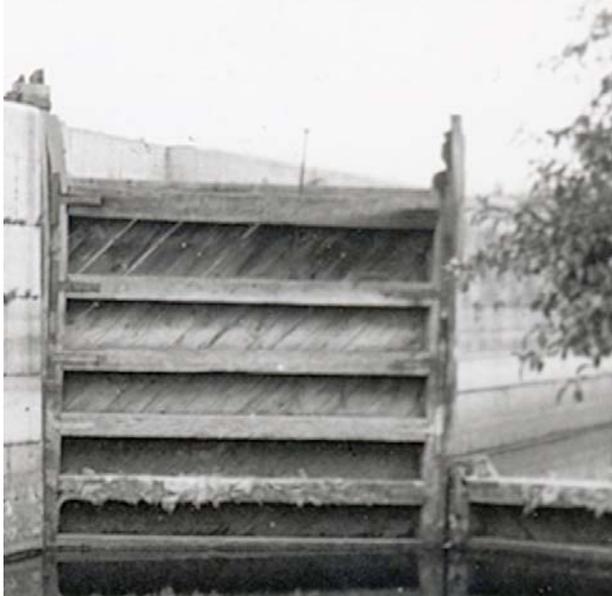
The above image of the E-56 lock gate is part of a series we had several years ago (1997) of the lock as it appeared in the late 1930's. The lock has been abandoned for about 15 years and during that time the gates deteriorated. What remains here is the south gate of the north lock chamber. The north lock chamber was the one that is lengthened.

This image is interesting because of the differential decay of these gates. The north gate is much more decayed, or is it simply vandalized or materials taken for re-use somewhere else? I suspect that much of the timbers on the lock were removed by salvage to be re-used elsewhere. In other early images of this lock considerable use of white oak can be found in lock gates, entries to lock chambers and elsewhere. Wood generally takes 100’s of years to decay naturally on the forest floor. In this case the wood is simply missing.

Already in the image you can see the destructive forces of plant and tree growth beginning. In the far right appears to be a small shrub or tree. Root systems from this growth cause the laid stone to separate, into which water flows. In the winter months this water freezes, exerting considerable hydraulic forces that further deteriorate the lock walls.
