1907 Postcard of E-56 Interpreted

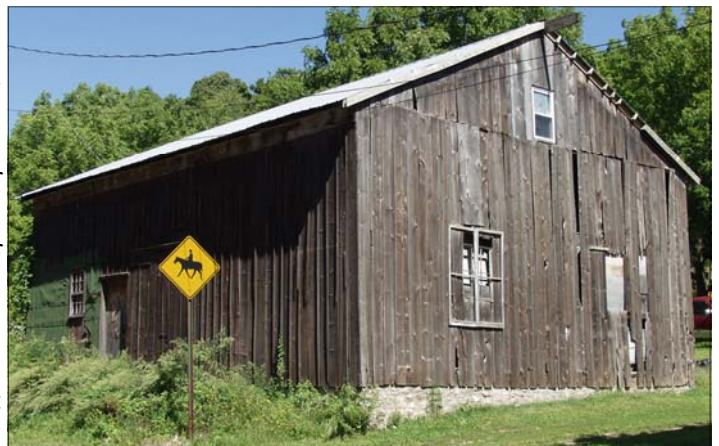
In the above Right Sector of the original postcard image is seen a farm building. The building at the right is a farm building found on Old Lyons Road. It bears a remarkable resemblance and is found at about the same location as the one in the postcard. The foundation of this building is of field stone, popular during the period of E-56. The land north of E-56 was farmland, some of which today is occupied by the current Erie Canal. Also of interest are the buildings on the crest of the hill in the distance. These are to be investigated at a later date. Much of the hills in the area were cleared of trees, not entirely true today.

In the **Right Sector** is the "quiet side" of the canal. Here there is no towpath but what appears to be a simple country lane and footpath past the north side of the lock. Farm buildings also appear in the background. Lyons, which is located just east of E-56 was famous for peppermint production. The Hotchkiss Company was world famous for color and purity of its peppermint. Farms in the area grew this crop, so its possible that the fields we see here are peppermint. They are fairly dense and short in stature. Peter Hill owned the land on both sides of the lock and may have been involved in the peppermint business. Also present are "telegraph" poles. They begin and disappear along the north side. Rural electrification was not largely available to all those in the countryside. In fact, when the New York State Barge Canal (NYSBC) was built (slightly north of this picture) around 1912, the state placed dedicated power stations for the new "electric" locks. This was mainly because of the unpredictable nature of early rural power systems. Lastly is the "hill". I do not believe it is there today. During construction of the NYSBC this hill may have been diminished and used to build up berm on the north side of the new canal.

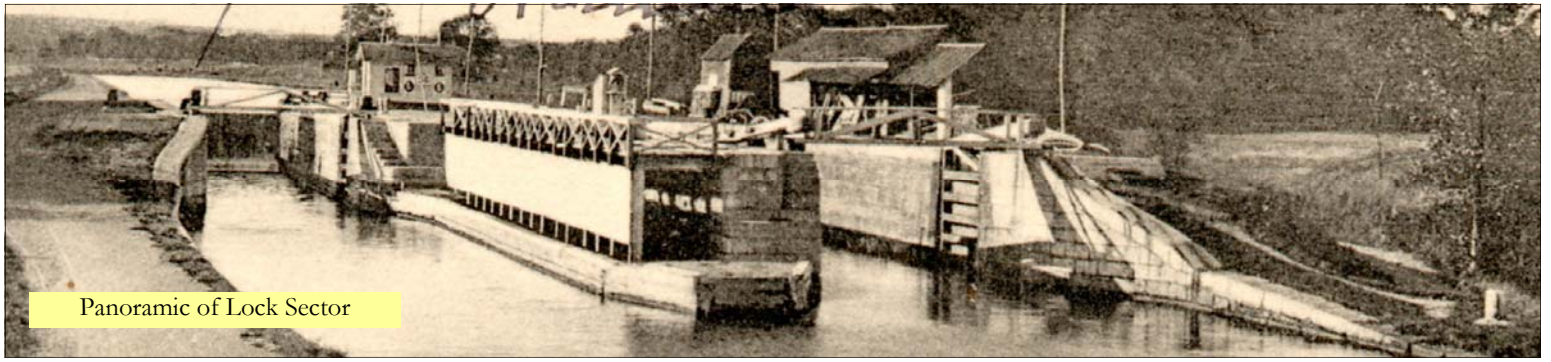
Panoramic of Lock Sector

Each Erie Canal Lock had a large sign showing the lock number. The number here can just be made out.
