What can be found at Enlarged Erie Canal Lock E-56, Today?

By John R. Groves

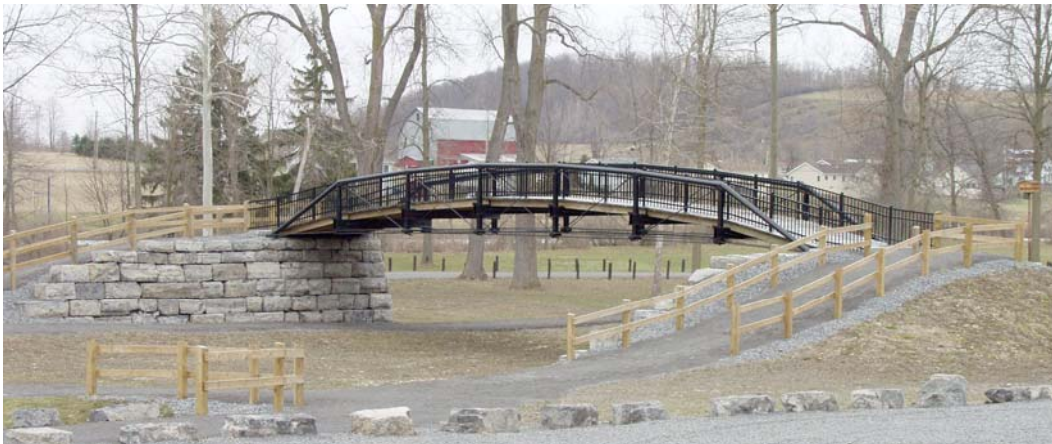
**JOHN HUTCHINSON. CONTRACTOR & BUILDER, TROY NY
G.W. EDDYS FOUNDRY. WATERFORD. NY 1858 .**

Above, The Aldrich Change Bridge #35 of the Enlarged Erie Canal Era located in the Palmyra /Macedon Aqueduct Park. Top, The center upper course on the bridge with the original foundry inscription.

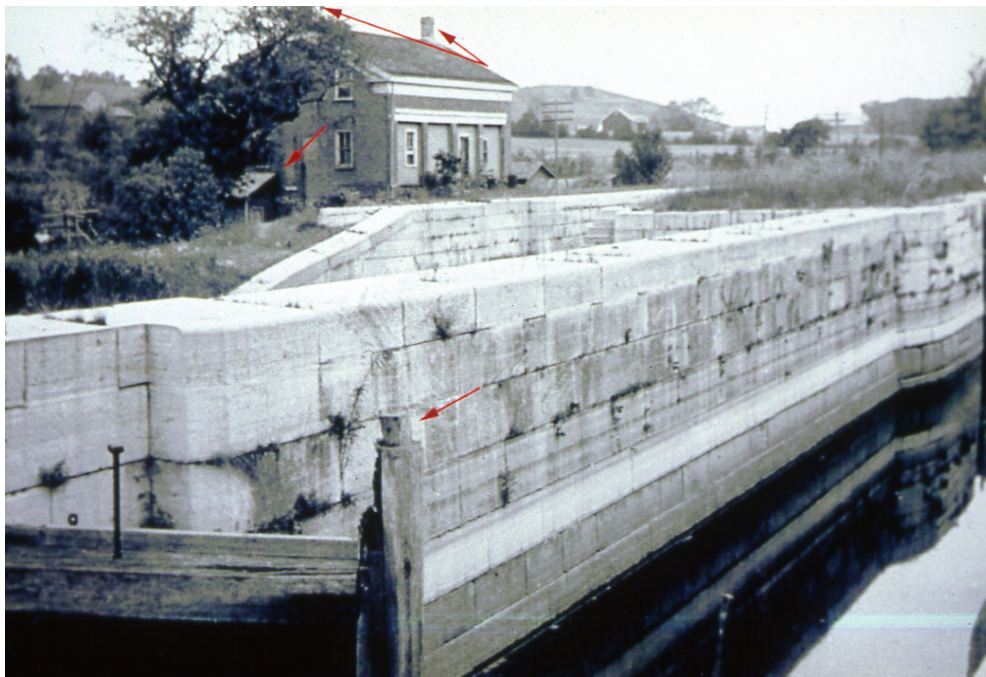
This 1930's image shows the E-56 lock about fifteen years after abandonment. Parts of the original east lock gate remains. The Balance Beam post still shows the joint for the Balance Beam. (*Red arrows point to references in this text*) On the east side are attached outbuildings as well as indications of other attached structures. Two chimneys appear, the east one now removed.

The "grocery" remains intact with a few external changes; such as a removed west chimney and other attached structures seen in early photographs. (Two images, 1887/1905, are published in the Field Trip Guide, October 26, 1991, **The Erie Canal – Eastern Wayne County**, Canal Society of New York State). The grocery has been home to the Perry family since the early 1940's and has been changed significantly inside. There are no documented images of the grocery as it would have appeared during the period of its use on the canal. One image surfaced a few years ago, from the Barben Collection (Seneca Falls) allegedly showing an interior of the grocery. This period image would have been typical of such stores during the Enlarged Erie Canal era.

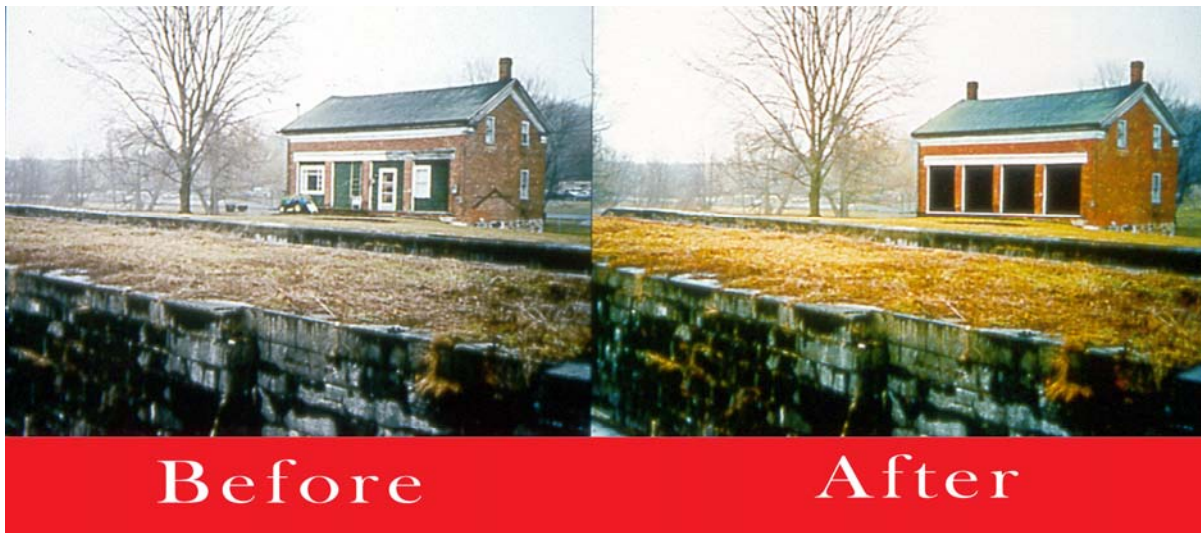
During the planning stages in 1994 the author did computer stimulations. Extraneous items were removed from the foreground and background. Openings in the building were “blacked out” as there are no records of how they might have appeared. A “new” chimney was added and the “saddle” on the roof line improved. During this period the lock chambers were completely cleared of brush and several interpretive signs were installed.

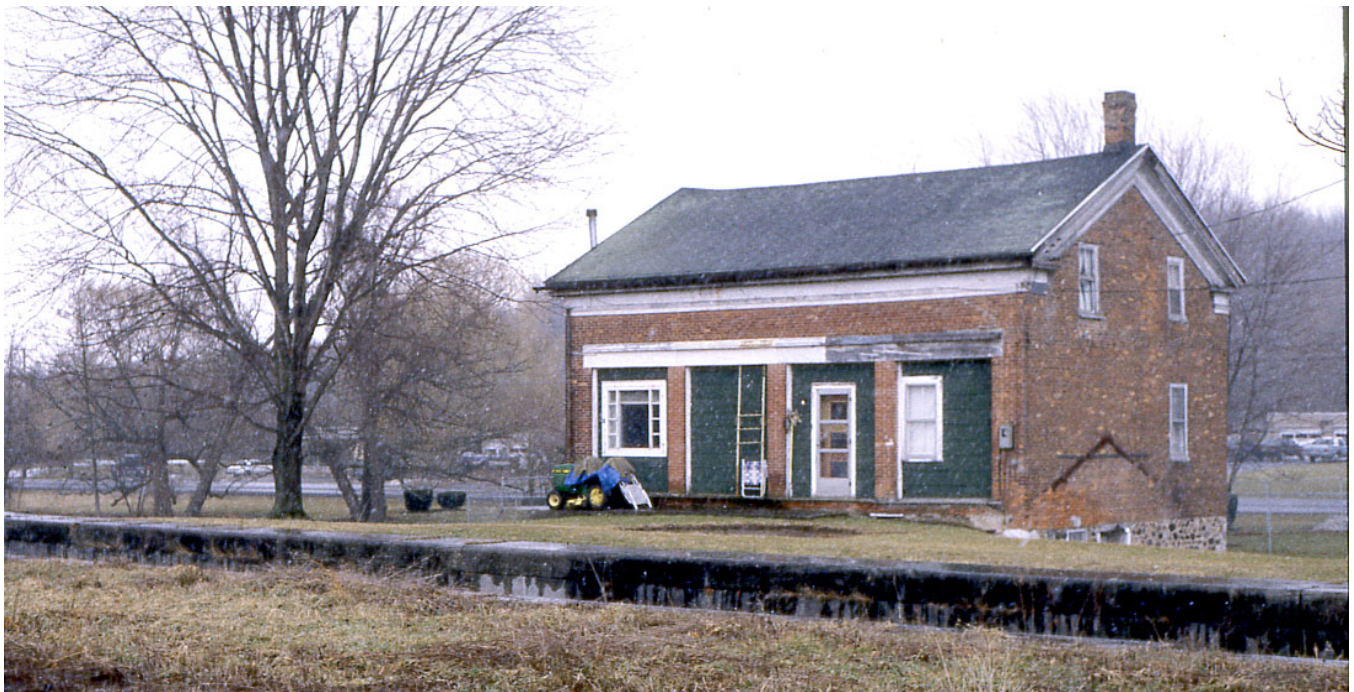
The lock and grocery are in relatively good shape. All that is needed is TLC to create an outstanding interpretive site for the Enlarged Canal Era (1835-1917). With the lock “re-watered” and operational it will be the only such site on the Erie Canal system.

The lock chambers are still intact and plumb. The walls, although impacted by small trees have not shifted or collapsed. The only noteworthy changes to the original Enlarged Erie version of E-56 are the "final improvements" that include poured concrete found at the west end and intermittently on lock walls. These were done between 1913 and 1917.
